WILDFLOWER SOCIETY OF WESTERN AUSTRALIA (Inc)

Re 2185 Northam-Pithara Road (M032) Seal Widening SLK 5.8 – 27.00

The Clearing Assessment Report

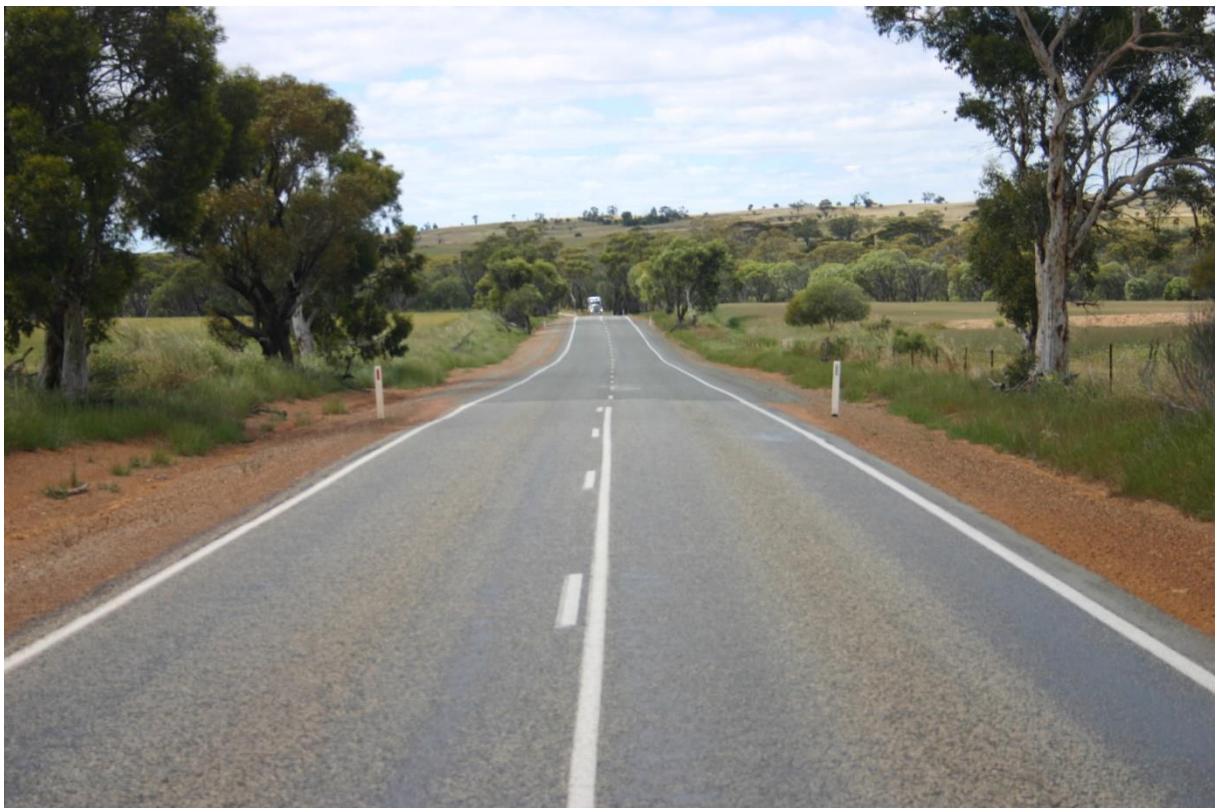
A section of road at SLK 20.0 has already been reconstructed with sealed shoulders and appears to occupy the full 20.0m of the road reserve with the drainage, as shown in Photograph 1 overleaf. About 500m south of this section, the entire shoulder has been eroded by water draining downslope from the top of the hill at about SLK 18.0, which suggests a larger table drain is required than currently available. The line of trees opposite this area of table drain extends from SLK 18.2 to SLK 19.3 on WSWA's estimation with an offset of less than 1.0m from the existing edge of bitumen for some individual trees.

Photograph 1: Area of reconstruction in area of different seal shade

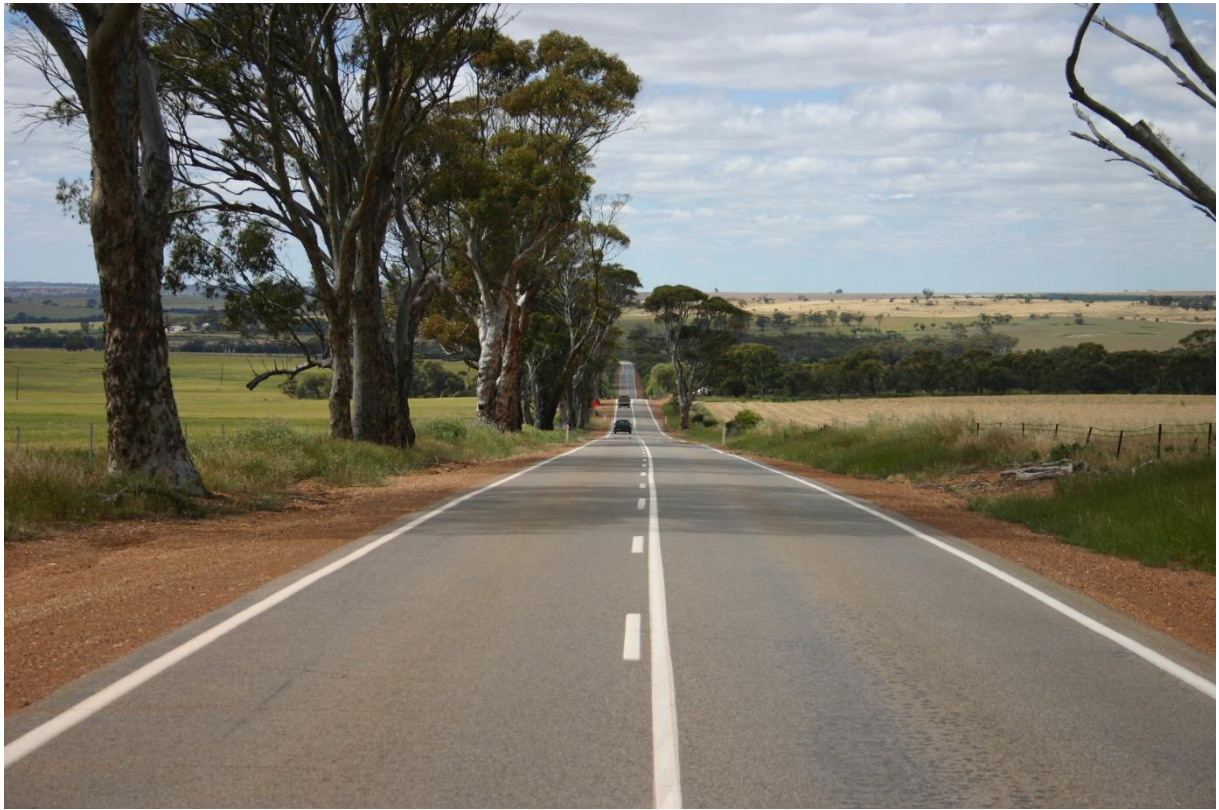
Immediately south of Habgood Road, a series of large Eucalypts sit within 1.5m of the existing edge of bitumen, as shown in Photograph 2.

Photograph 2: Large eucalypts growing on west side of the road from SLK 18.2. Reconstructed section shown in Photograph 1 is located before the left hand bend in the distance. Washed out table drain commences before large tree on right hand side. Trees on the left range in age to in excess of 100 years.

WSWA would seek to have the use of safety barriers extended to allow the retention of all aged trees along the left hand side of the Project area so their intrinsic value in the landscape and the roadscape is protected. These trees offer a visual diversity in the roadscape that allows a break in the visual monotony that occurs where vegetation is non-existent or where the viewscape along the road is visually consistent. The diversity of viewscape is important to the safety of the road (Centre for Road Safety Research, pers.comm).

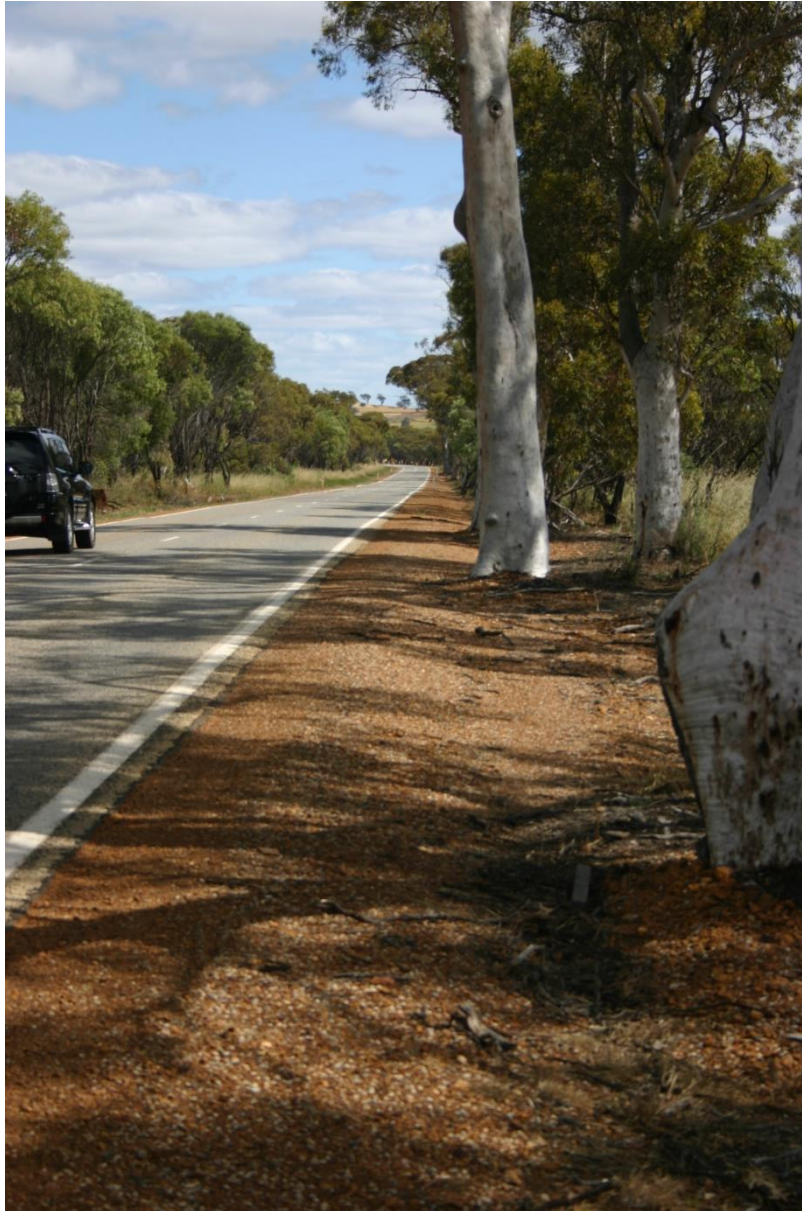
Photograph 3: Tree in foreground is 1.3m to edge of bitumen. Tree in background is 0.8m to edge of bitumen. Both trees are in excess of 50 years old.
