## WILDFLOWER SOCIETY OF WESTERN AUSTRALIA (Inc)

### **Re: CPS 10159/1 – City of Busselton North Jindong Road Clearing**

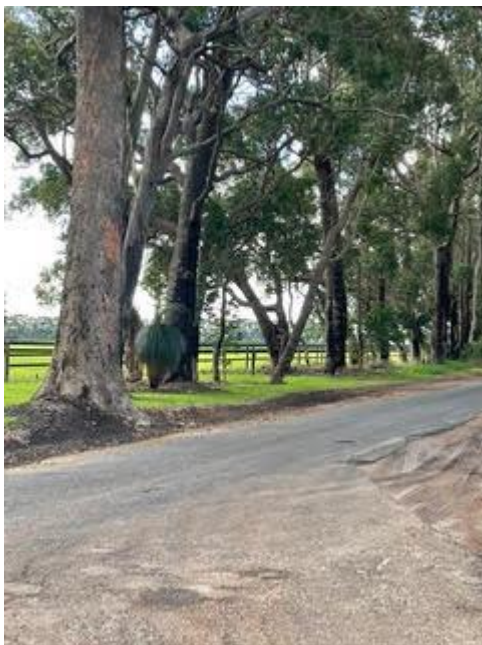
Old growth marri could be protected by guard rail

- Street verge has remnant native trees and plants that should be conserved
- Mature marri trees close to road could be preserved (see photo.)
- Balga grass trees could be relocated
- There is no refuge for wildlife flora or fauna if clearing beyond that already completed, is allowed
- Properties adjacent to the road have been cleared.
- Low traffic use as these are minor roads
- No crash data at this site to date
- Fire safety risk is small scale due to isolated vegetation.

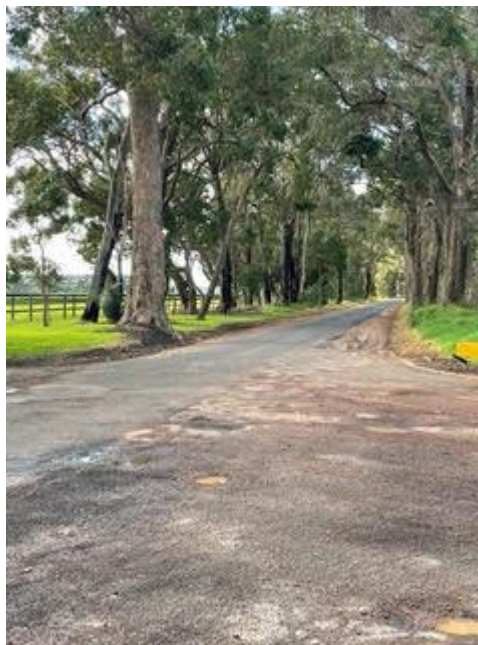
Lower speed environment on approaches to intersection to improve safety

- Highlight mature trees close to road with reflectorised tape markers
- Erect warning signs for drivers to highlight the presence of hidden driveway entrances
- Install white edge lines on road edges to highlight the limits of the sealed running surface
- Localised reduction of speed limits with enforcement
- Private driveways to install mirrors to improve safe access to the road.

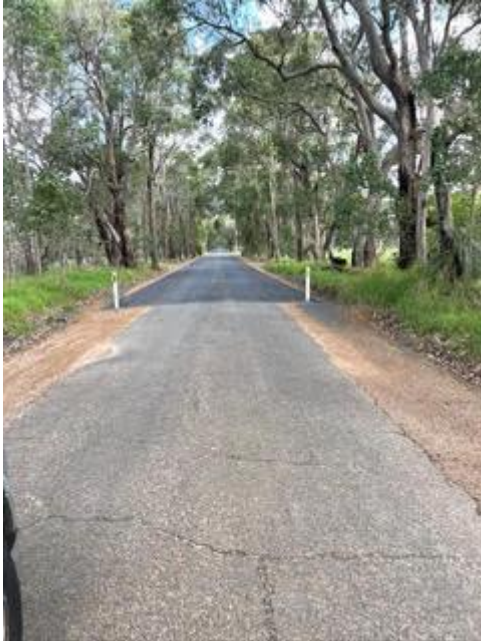
Comparison between old and new surfaces

This section of the road has a broken bitumen sealed surface and rough gravel verges. Either side of this section, road works have been completed to stabilise tarmac and smooth gravel verge with minimal vegetation removed. The clearing proposed in this permit application is inconsistent with that completed previously to correct similar road degradation.

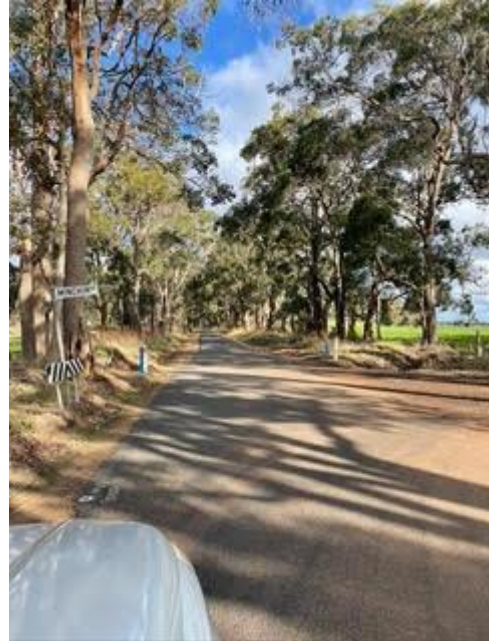
Road intersection. Note road formation available from existing road surface to guide post compared to photo on left.
